Kelly Horne - Marshal Ditch Order

From: Susan Odekirk
To: ralph.perkins@garfk12.org
Date: 4/18/2011 11:07 AM
Subject: Marshal Ditch Order
CC: Forbush, Kirk; Owens, Ray
Attachments: Marshal Ditch.SO.4-18-2011.doc

Last August The Division of Water Rights issued a Notice that the head gate and measuring device for the Marshall Ditch required repair and that repairs need to be made prior to diverting water in the spring of 2011.

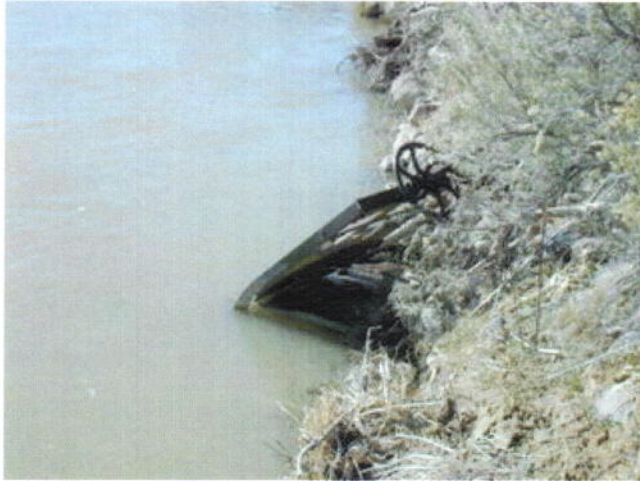
Head Gate

The stem is bent enough that the gate can't fully close and open. We need the gate to be repaired or replaced so that it can be fully opened and fully closed.

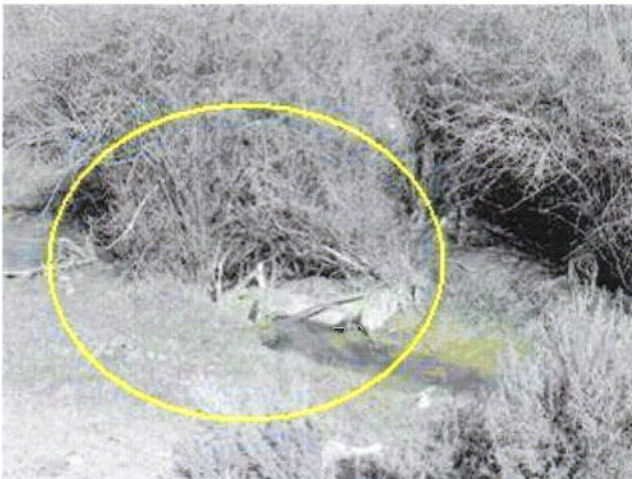
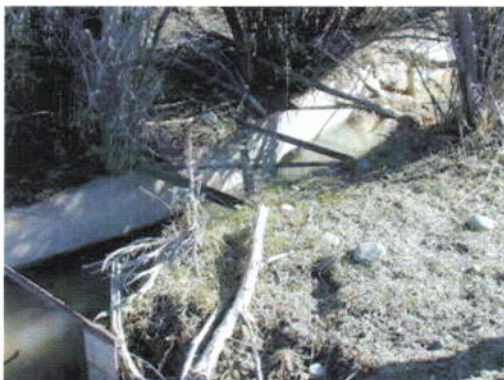
Flume – water goes through culvert, down little hill and onto flat section. Flume is in the flat section (pictured in yellow circle)

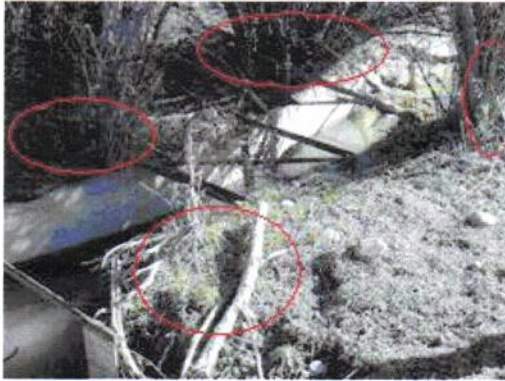
Two concerns with the measuring device:

1. Bushes make it hard to properly read the water level in the flume. Need 4 bushes removed or cut down to ground.
2. Sediment has built up in the front part of the flume and the channel approaching the flume (0-10 feet in front) That sediment needs to be cleaned out from the flume itself and the 10 feet or so in front so that the water flows smoothly into the flume. Heavy equipment shouldn't be needed because the sediment is only a concern in the flume and very near the approach to the flume.
